## GT component repairs: Why value matters

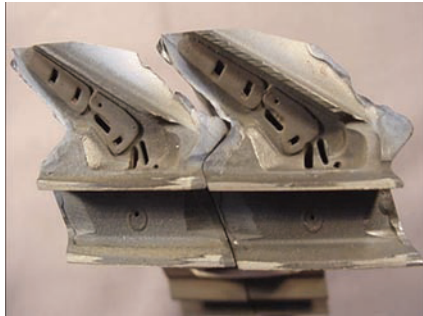
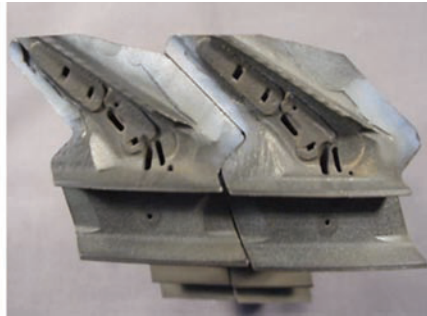
26. Conventional weld repair of HPT blade shrouds (left) looked like this after 13,000 hours of operation; upgraded extended-life repairs (right) remained “like new” after 24,000 hours

- Operational risk reduction by the “resetting” of design safety margins.
- “Upgrade” repairs that make components “better than new” by correcting weaknesses in the original design. Some examples offered as “value” repairs are these:
  - Shrouded-blade weld repair, an upgrade that extends component life (Fig 26). To illustrate: Conventional weld repair of shroud edges for RB211 (Rolls-Royce) high-pressure turbine (HPT) blades after 13,000 hours of operation are at left; upgraded extended-life repairs using advanced filler metals (right) seem almost new after 24,000 hours. Blades at the right

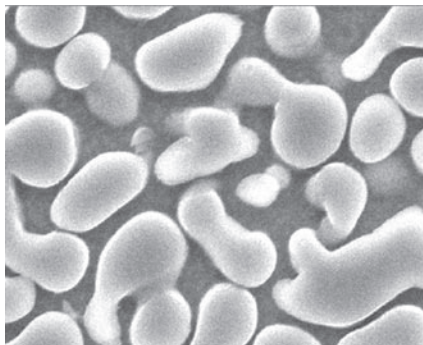
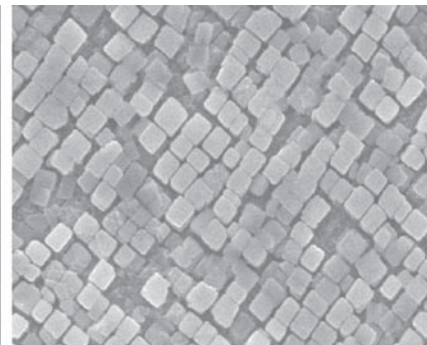
28. Service-exposed material from a directionally solidified first-stage bucket (left) must undergo “full-solution” heat treatment (right) to rejuvenate the gamma-prime phase of the D111 alloy

By contrast, a “full-solution” heat treatment using a hot isostatic process (HIP) fully rejuvenates alloy creep strength. You pay a premium for this procedure because furnace time is longer than for a partial treatment and there is the added HIP cost. Metallurgically speaking, proper full-solution rejuvenation would “reset” component microstructure to a virtually as-new condition (Fig 28).

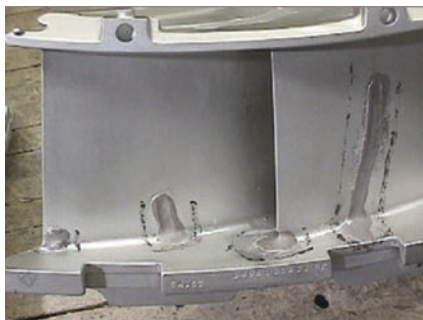
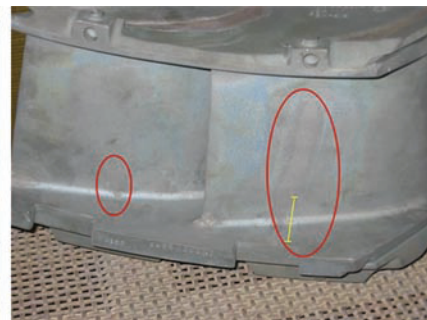
29. Nozzles after 48,000 hours of service (left) exhibit areas with large cracks. These were repaired with Liburdi’s proprietary high-strength LPM material. After 92,000 hours, areas where cracks were repaired show little re-cracking and sometimes none. LPM material can be re-repaired to further extend service life
